Dave Lochbaum: Summary of November 2022 NRC Violation at Indian Point

On November 17, 2022, the U.S. Nuclear Regulatory Commission (NRC) issued a report on oversight efforts performed by eleven NRC inspectors at Indian Point. The NRC's report included one violation "for failing to develop and implement a radiation protection program to minimize the introduction of residual reactivity into the site."

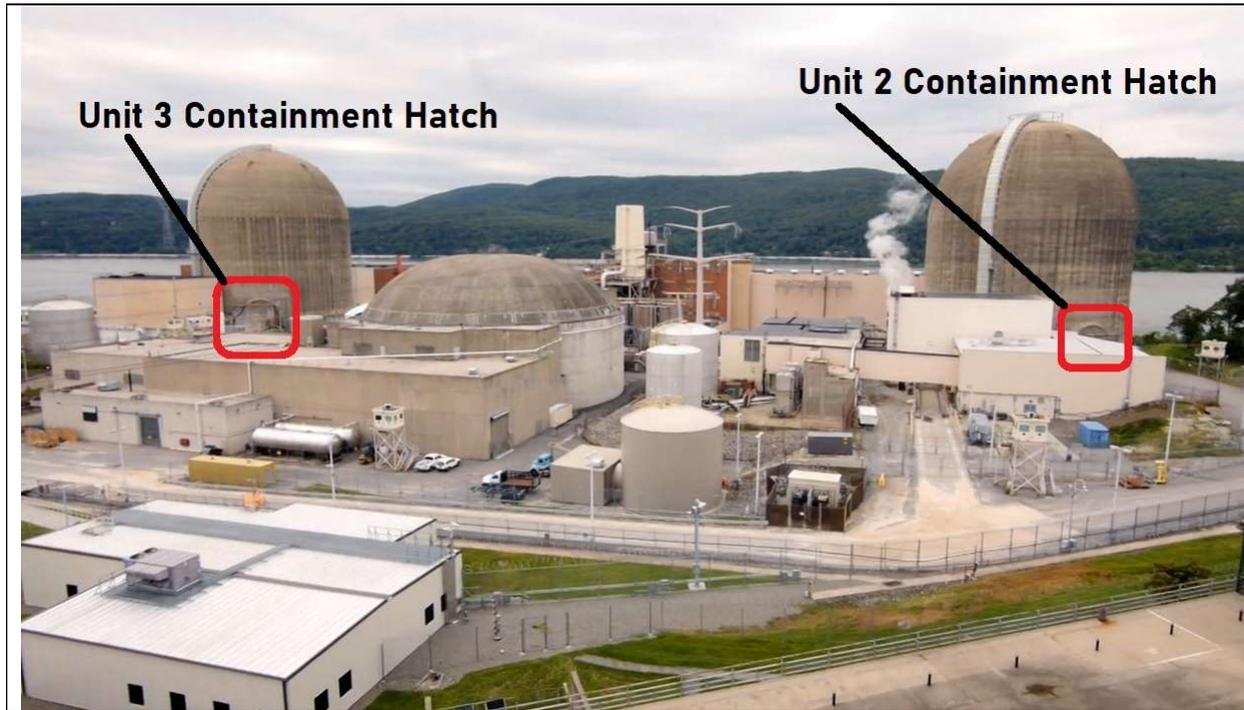
The picture above shows Unit 3 on the left and Unit 2 on the right. Encased within the red rectangles are the original round equipment hatches (lower portions obscured by other structures.)

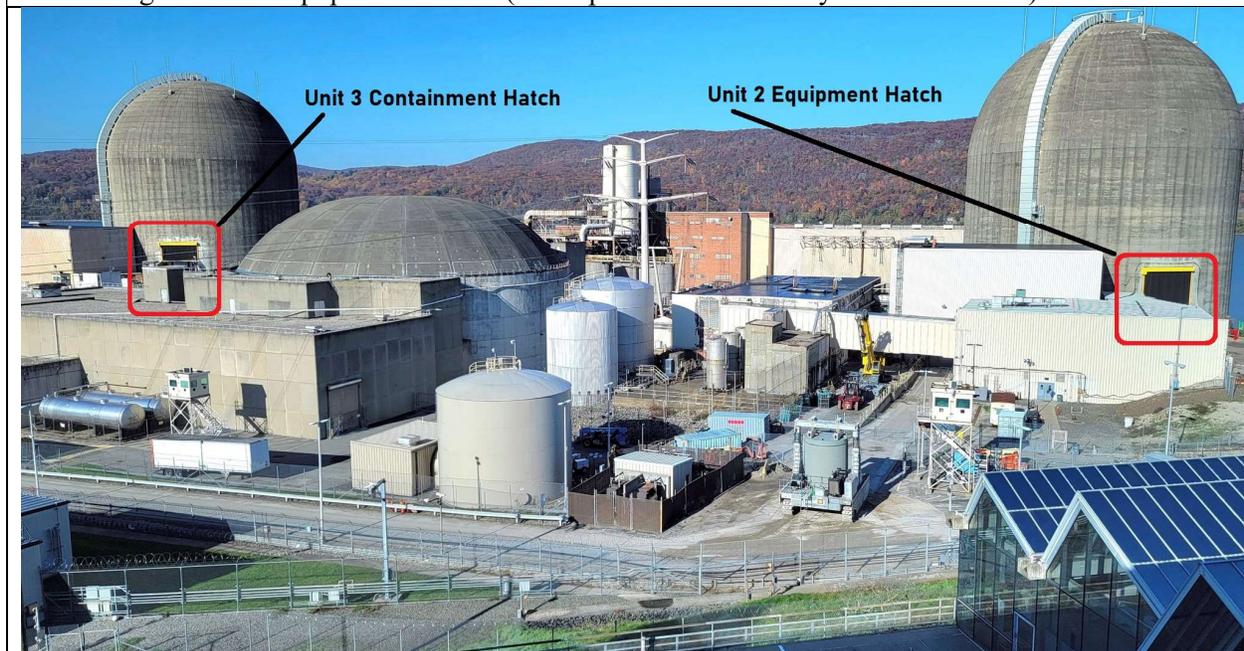
The picture above shows Unit 3 on the left and Unit 2 on the right. Encased within the red rectangles are the enlarged, rectangular equipment hatches (lower portions obscured by other structures.)
